**Hurricane Milton**  
 October 9, 2024  
 Released: February 24, 2025  
 NHERI DesignSafe Project ID: PRJ-5689

**PRELIMINARY VIRTUAL RECONNAISSANCE REPORT (PVRR)**

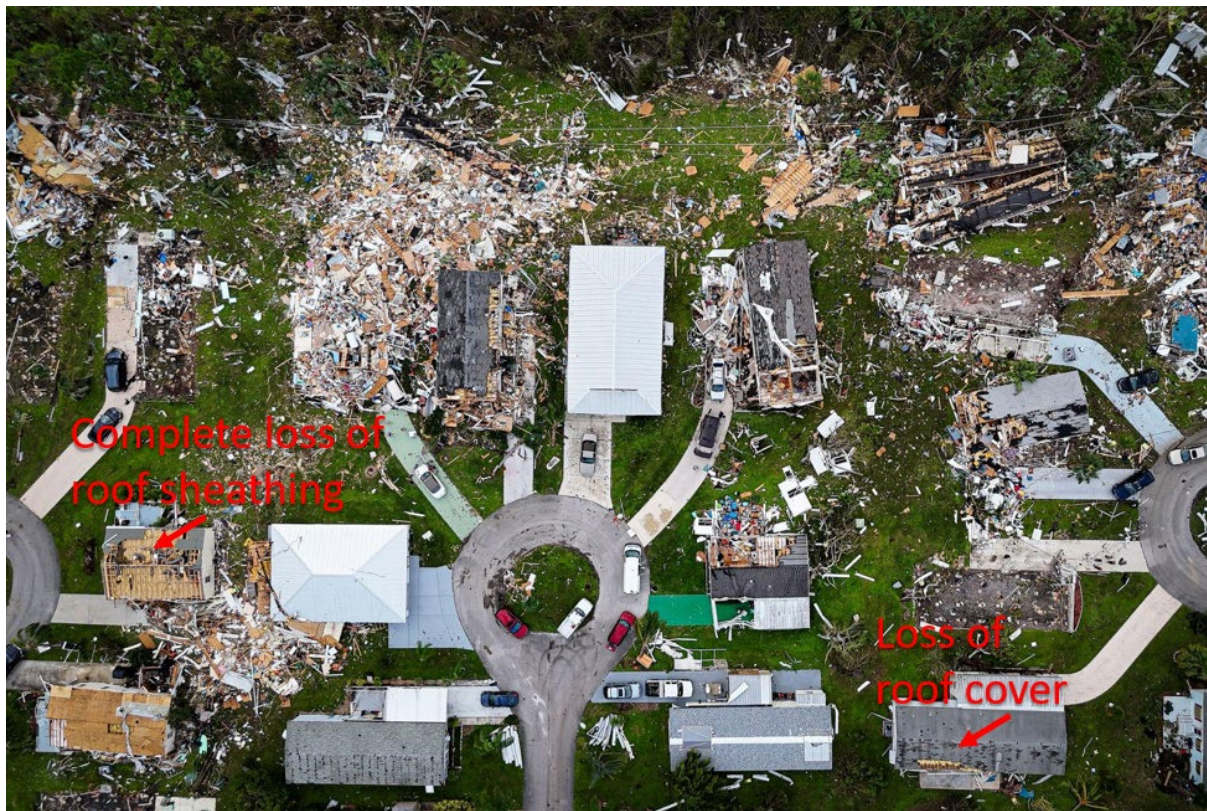
**Figure 4.1.** Damaged residential buildings in the Spanish Lakes community impacted by an EF3 tornado with variable levels of structural and roof damage (Source: [Miguel J. Rodriguez Carrillo](#)).

Another notable case study was the Spanish Lakes community, which was struck by an EF3 tornado, causing six (6) fatalities. The community consisted of a mix of modern site-built homes adjacent to older mobile/manufactured homes (Fig. 4.4). A review of aerial imagery confirmed that no site-built homes suffered any observable structural damage, while dozens of mobile/manufactured homes were dislodged from their foundations and/or completely destroyed. It is believed that all fatalities at this site occurred in mobile/manufactured homes.

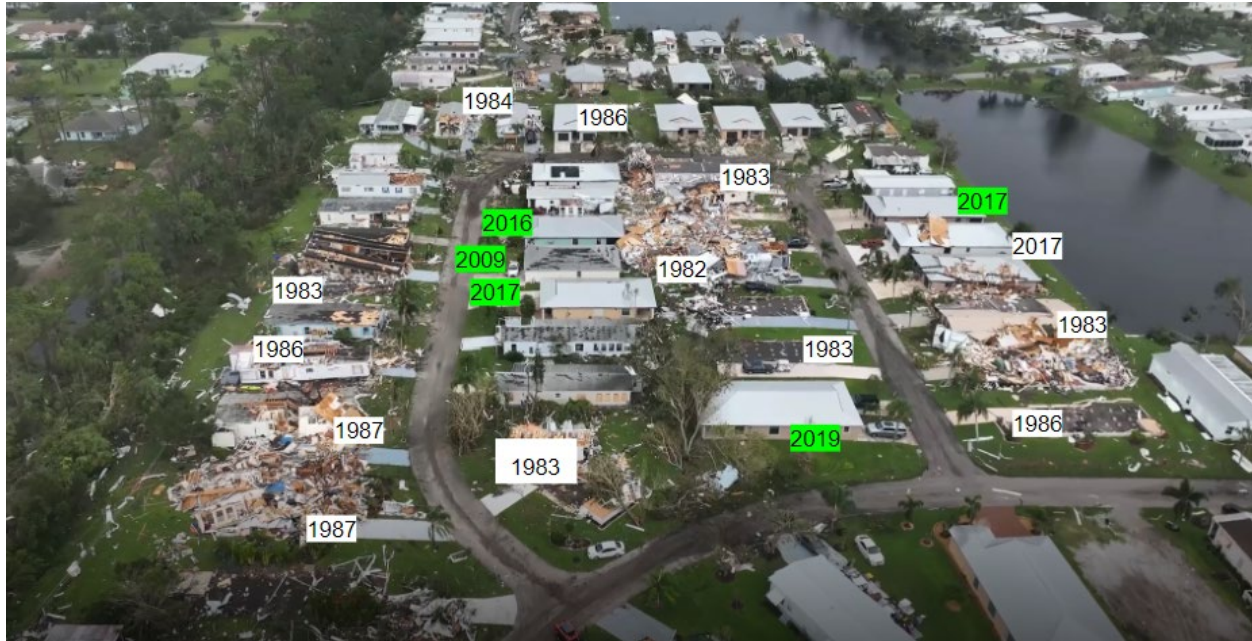
**Figure 4.4.** Tornado damage path through the Spanish Lakes community near Ft. Pierce.

Approximate year of construction is provided in the annotations, with green highlights representing that for site-built homes and white for mobile/manufactured homes (Source: [NY Times](#), with annotations by the StEER VAST).

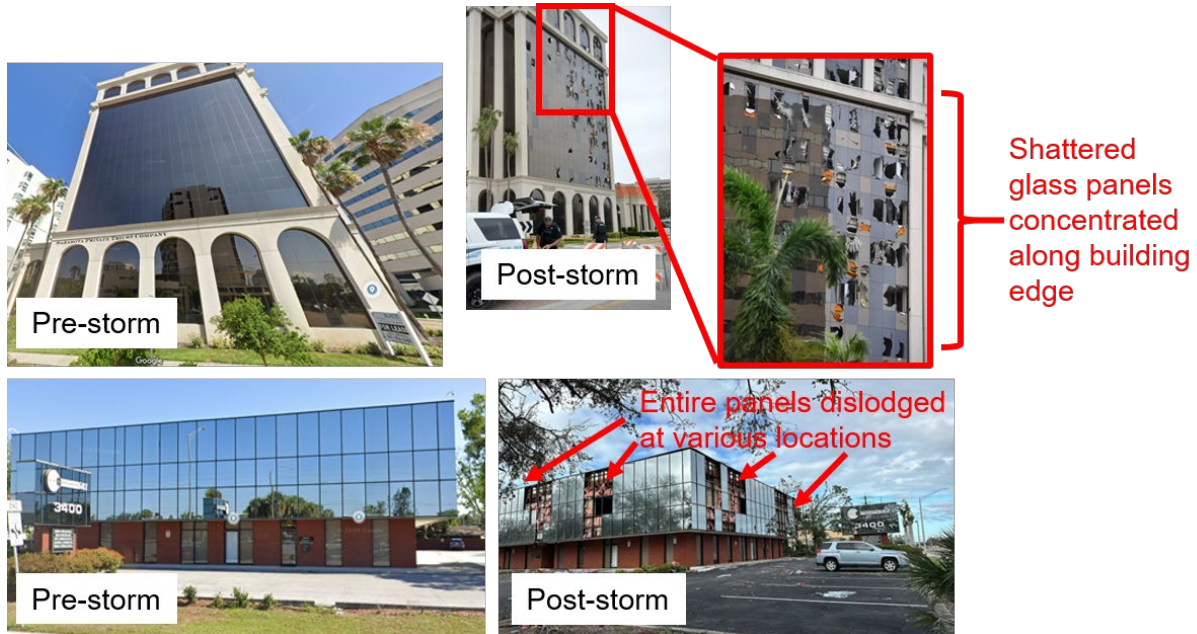
Figure 4.5 shows several buildings with glass facades sustaining damage during this hurricane. The building in the middle of the top panel is the Sarasota Private Trust Company building in Sarasota. The aerial images of the buildings surrounding this building do not show that adjacent buildings had gravel covered roofs or other debris sources. The concentration of shattered glass panels with otherwise enacted assemblies near the building corner suggests that strong edge pressures were the likely cause. By contrast, the building in the bottom right in Figure 4.5, the Sarasota Retina Institute, has entire window assemblies missing along two faces of the building, well away from the building corners. Aerial images of the surrounding buildings similarly show lack of obvious debris sources, possibly suggesting the assembly attachments may have failed either due to insufficient capacity or possible degradation over time.

**Figure 4.5.** Shattered glass panels at Sarasota Private Trust Company (top) and dislodged window panes at Sarasota Retina Institute (Sources: Top left and middle [Mike Lang](#), top right, bottom left, and bottom right: [Derek Gilliam](#)).

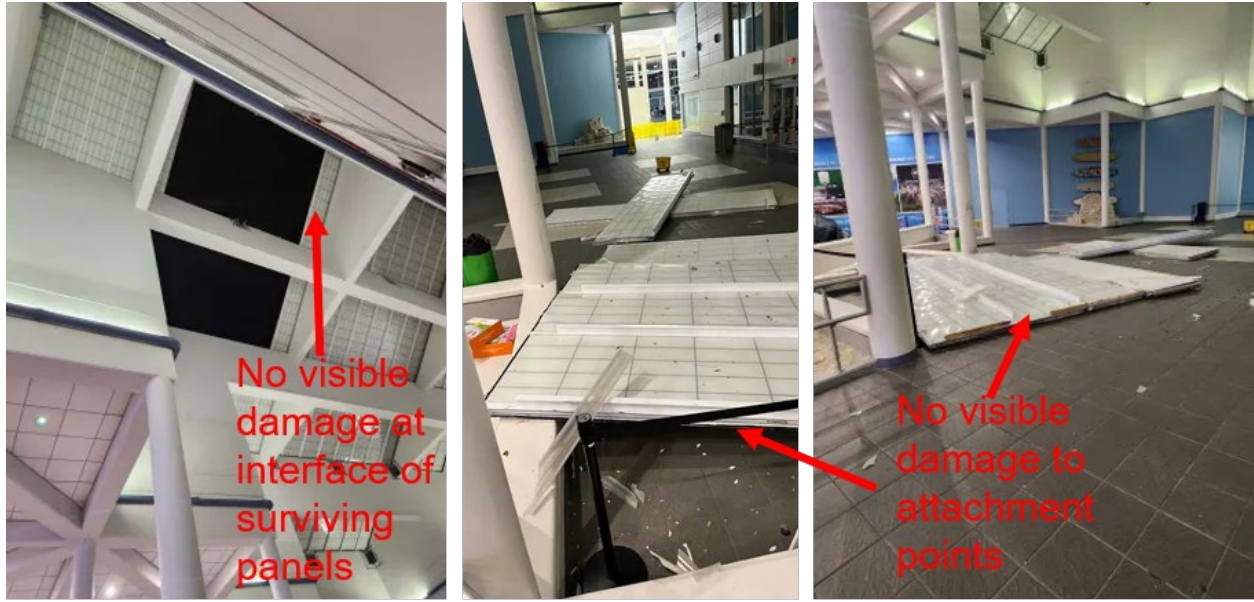
A 30-by-40-foot section of skylight at the Melbourne Orlando International Airport collapsed onto the terminal floor due to intense winds generated by Hurricane Milton, as illustrated in Figure 4.6. There is no visible damage to any of the skylight panels (those that remained in place and those that fell to the ground); their boundaries show no visible failure of attachments. It is possible that the panels, which are modular, were unseated due to fluctuations under the wind experienced wind pressures, possibly bowing sufficiently out of plane to eventually become unseated. Despite the large opening created by the collapse, dry conditions during the event minimized water intrusion into the building. As shown in the aerial view (Fig. 4.7), the skylight is located in the terminal's central atrium area. While the airport underwent major renovations and expansions in 2017 and 2021, it is unclear whether the skylight was updated during these projects. Fortunately, the failure occurred around 2 a.m. on October 10, 2024, when the terminal was closed, fortunately preventing injuries. Nonetheless, the failure of these roof panels in such a high-traffic atrium warrants further investigation given its life-safety implications.

**Figure 4.6.** Skylight failures at Melbourne Orlando International Airport where entire skylight panels were apparently unseated under wind gusts. No visible damage to the panels or their attachments is apparent (Source: [Jennifer Sangalang/USA TODAY NETWORK](#)).

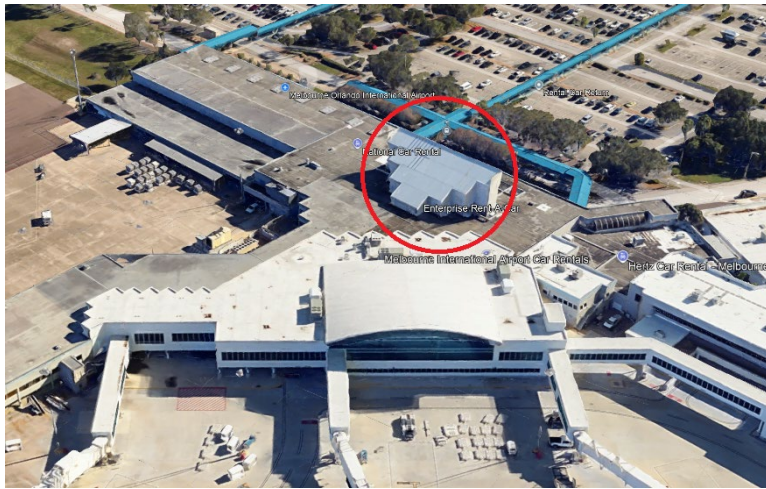
**Figure 4.7.** Aerial exterior view of the Melbourne Orlando International Terminal. The skylight that failed due to wind is circled in red (Source: Google Earth).

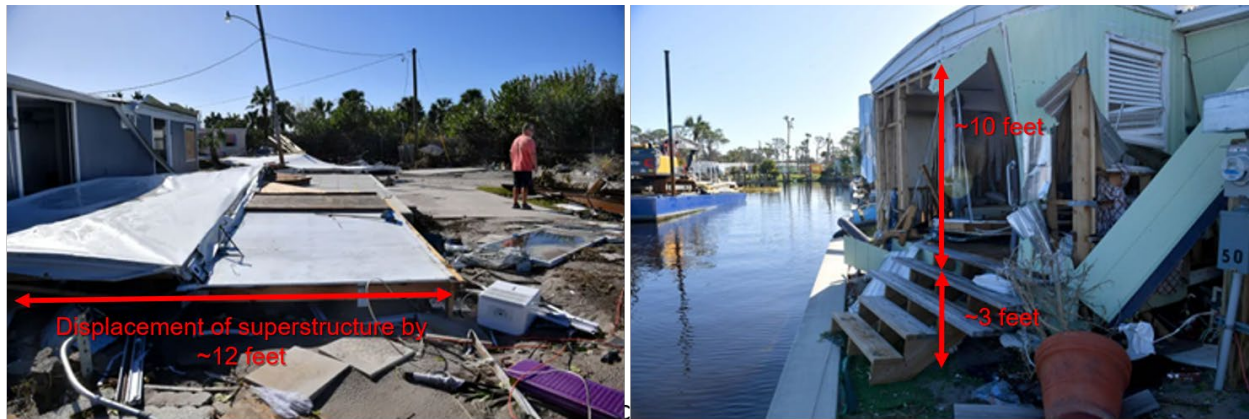
Hurricane Milton caused extensive damage at Shady Haven Mobile Home Park in Englewood, Florida, primarily due to storm surge. As noted in Figure 2.5, this area experienced approximately 7 feet of storm surge above MSL. Figure 4.8 depicts two mobile homes in the community. The home on the left was displaced inland by 12 feet. The home on the right, in addition to being displaced from its base, also sustained severe damage to its façade, interiors, and wood structure due to storm surge and potential transported debris. Figure 4.8 provides visual references based on typical dimensions of typical mobile homes.

**Figure 4.8.** Destruction of mobile homes in Shady Haven Mobile Home Park in Englewood, FL, caused by storm surge: (left) mobile home displaced 12 feet from foundation; (right) mobile home also displaced from its foundation with severe wall damage from storm surge (Source: [Mike Lang/Sarasota Herald-Tribune](#)).

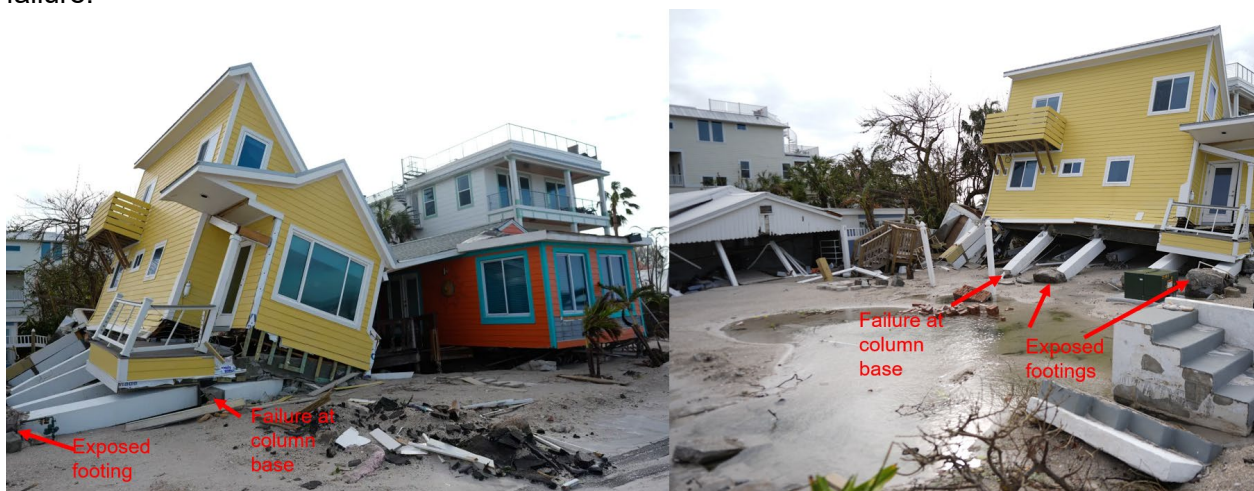
A yellow elevated house located on the barrier island of Bradenton Beach, near Tampa Bay, experienced a failure of its elevated foundation. As shown in Figure 4.9, the concrete piles supporting the structure rotated rigidly at their bases, causing the elevated foundation to fail. Exposed footings in Figure 4.9 suggest the piles were fairly shallow. The fairly good condition of the surviving property in the left image of Figure 4.9 does not suggest a storm surge sufficient to cause a failure of the yellow elevated home. A photograph taken after Hurricane Helene and before Hurricane Milton shows that the house on the left side of the failed yellow home had already been completely removed before Hurricane Milton, ruling out the possibility that the elevated house was rammed by the adjacent lower-elevation home. However, it remains possible that other objects, such as vehicles, boats or other debris, could have impacted the piles and instigated the failure.

**Figure 4.9.** Overturned yellow elevated house on concrete piles on the barrier island of Bradenton Beach near Tampa Bay (Source: [Rebecca Blackwell/AP](#)).

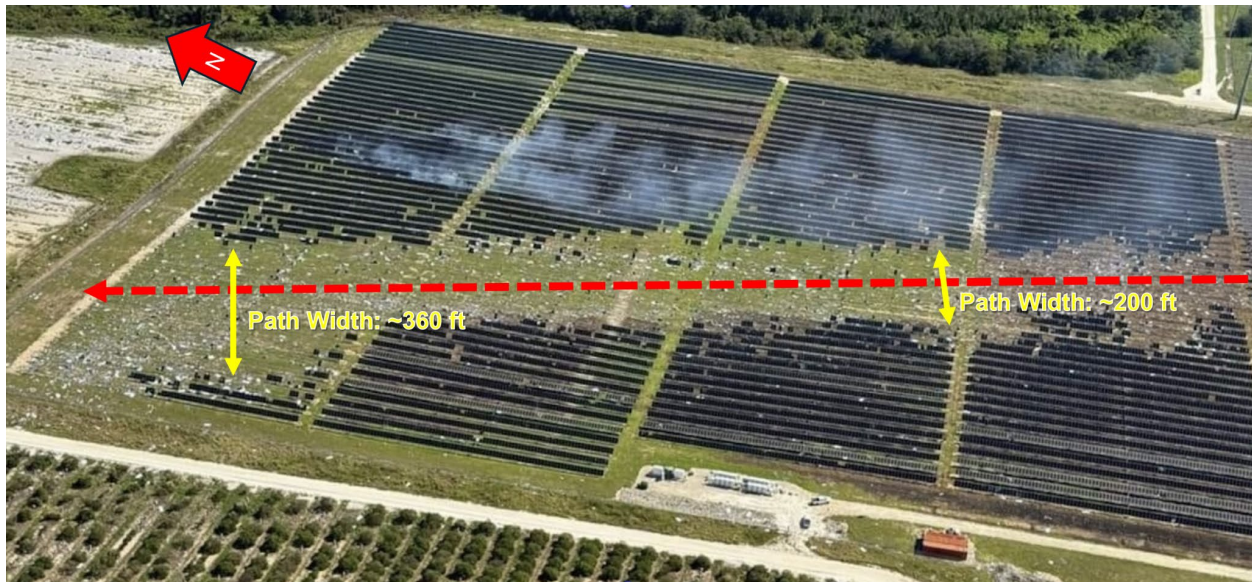
An EF-2 tornado spawned by Hurricane Milton struck Duke Energy's Lake Placid Solar Power Plant in Highlands County, Florida, on October 9, 2024. Although much of the facility was left intact, the western quadrant of the plant suffered the most severe destruction, with solar panels torn from their single-axis trackers and scattered across the site (Fig. 5.2).

**Figure 5.2.** Tornado damage to the Lake Placid Solar Power Plant in Highlands County, FL (GPS: 27.333993, -81.360365). The tornado path and direction are indicated by the red dashed arrow. The tornado damage width was between 200-360 ft as it passed through the solar farm (Source: [Duke Energy](#)).

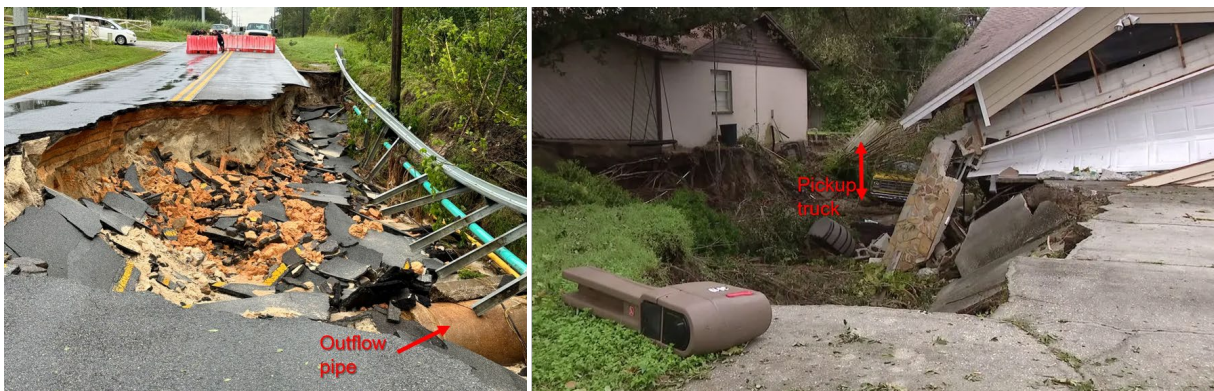
Milton-affected regions in Florida experienced severe soil erosion due to heavy rainfall, leading to road failures. The [Media Repository](#), curated with this report in DesignSafe (Kameshwar, et al., 2024), provides a wide cross section of geotechnical failures observed in Hurricane Milton, an example of which is shown in Figure 6.1 associated with heavy rain conditions in Mt. Dora. Sinkhole formations were reported in Hillsborough County and Polk County; the example in Figure 6.1 on Willow Wisp Drive in Polk County, was deep enough to consume a pick up truck and resulted in structural damage to a neighboring home (Bowen, 2024).

**Figure 6.1.** Example of geotechnical failures in Hurricane Milton (left) collapse of Wolf Branch Road at Niles Road in Mt. Dora adjacent to body of water receiving outflow; (right) sinkhole between two residences in Polk County, swallowing a pick up truck and leading to partial collapse of garage (Source left: [Daily Commercial](#); Source right: Bowen, 2024).

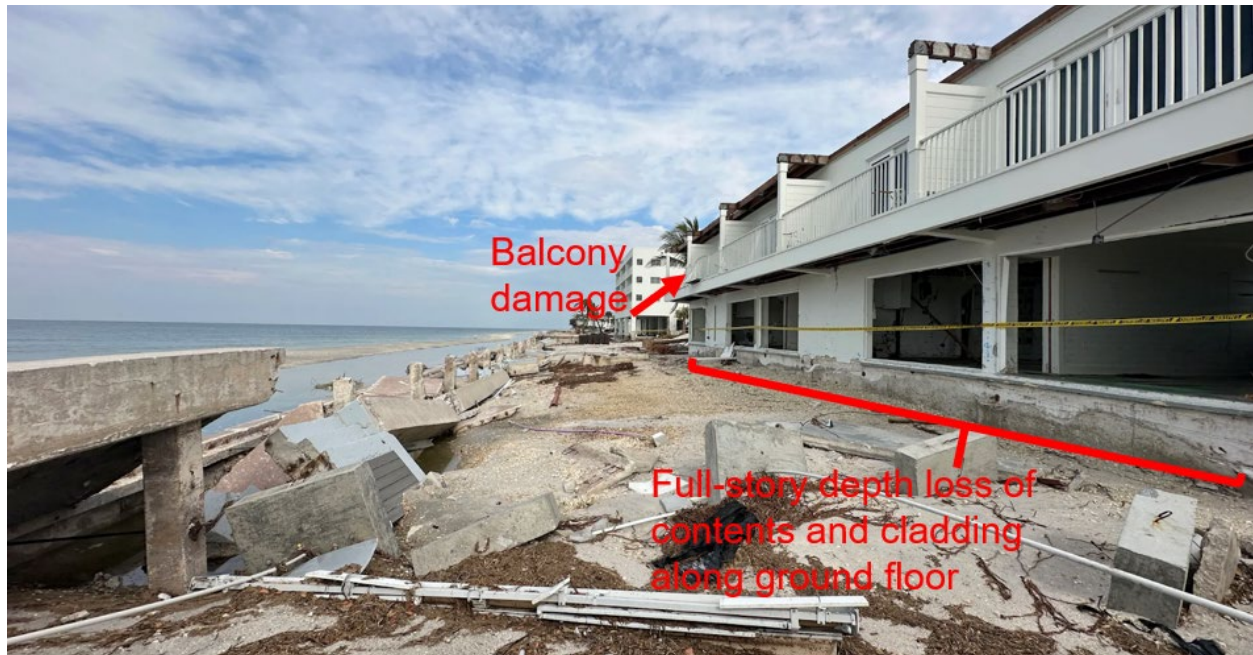
Petersburg. Storm surge also overwhelmed the seawall in Boca Grande, depositing 2 feet of water and 4 feet of sand on North Beach Road, obstructing access to local businesses (Wheelen, 2024). On Captiva Island, storm surge and sand overwash exceeded levels in Hurricane Helene, but not Hurricane Ian in 2022 (Southwest Florida Conservation Council, 2024).

**Figure 7.1.** Seawall failure associated with storm surge in Manasota Key; depth of storm surge evident from loss of ground floor unit cladding and contents suggesting storm surge to full height of ground floor (Source: [Mike Lang/Sarasota Herald Tribune](#)).

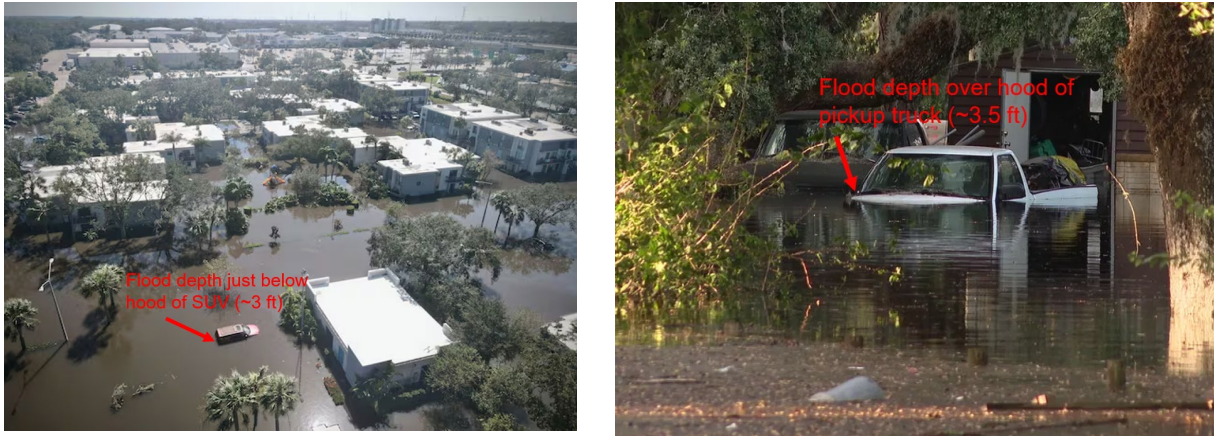
However, groundwater flooding, overwhelming inland canals in urban estuaries, was likely a primary driver of total damages associated with this event. Aquifers in western Florida are extremely shallow, with depths to groundwater averaging 0-10 feet throughout Hurricane Milton's impact area. Thus, even after typical rainfall events, extensive freshwater flows are still observed in canal systems across all urban estuaries surrounding the Caloosahatchee River, Charlotte Harbor, Manatee River, and Tampa Bay. These base flows represent groundwater flowing out of the terrestrial system into the ocean and increase in response to heavy rains and storm surges. As groundwater moves slowly, groundwater flooding may begin significantly after the storm passes and may persist significantly longer, even in the absence of significant storm surge. For example, the neighborhood of Clearwater in Tampa was inundated by 6 feet of freshwater due to saturated drainage systems, despite the reverse storm surge (Fig. 7.2). Thus, while pluvial and fluvial mechanism dominated flooding in the immediate aftermath of the storm, groundwater flooding led to persistence of floodwaters well after the hurricane passed (Hollis 2024). In the case of Milton, canal and stormwater systems remained overwhelmed for weeks (Lewis, 2024) (Fig. 7.2).

**Figure 7.2.** Estimated 3 feet of groundwater flooding in the Clearwater neighborhood in Tampa (left); over 3 feet of sustained groundwater flooding in Ridge Manor (Sources: left: Hollis, 2024; right: [FOX 13](#)).
